Mingenew Hall Restoration 2024

Read these drawings in conjunction with the "Mingenew Hall Options 2024 - Brief and Scope Report" by Studio Mango, January 2024, and the design video.

Drawing Title
Demolition Plan

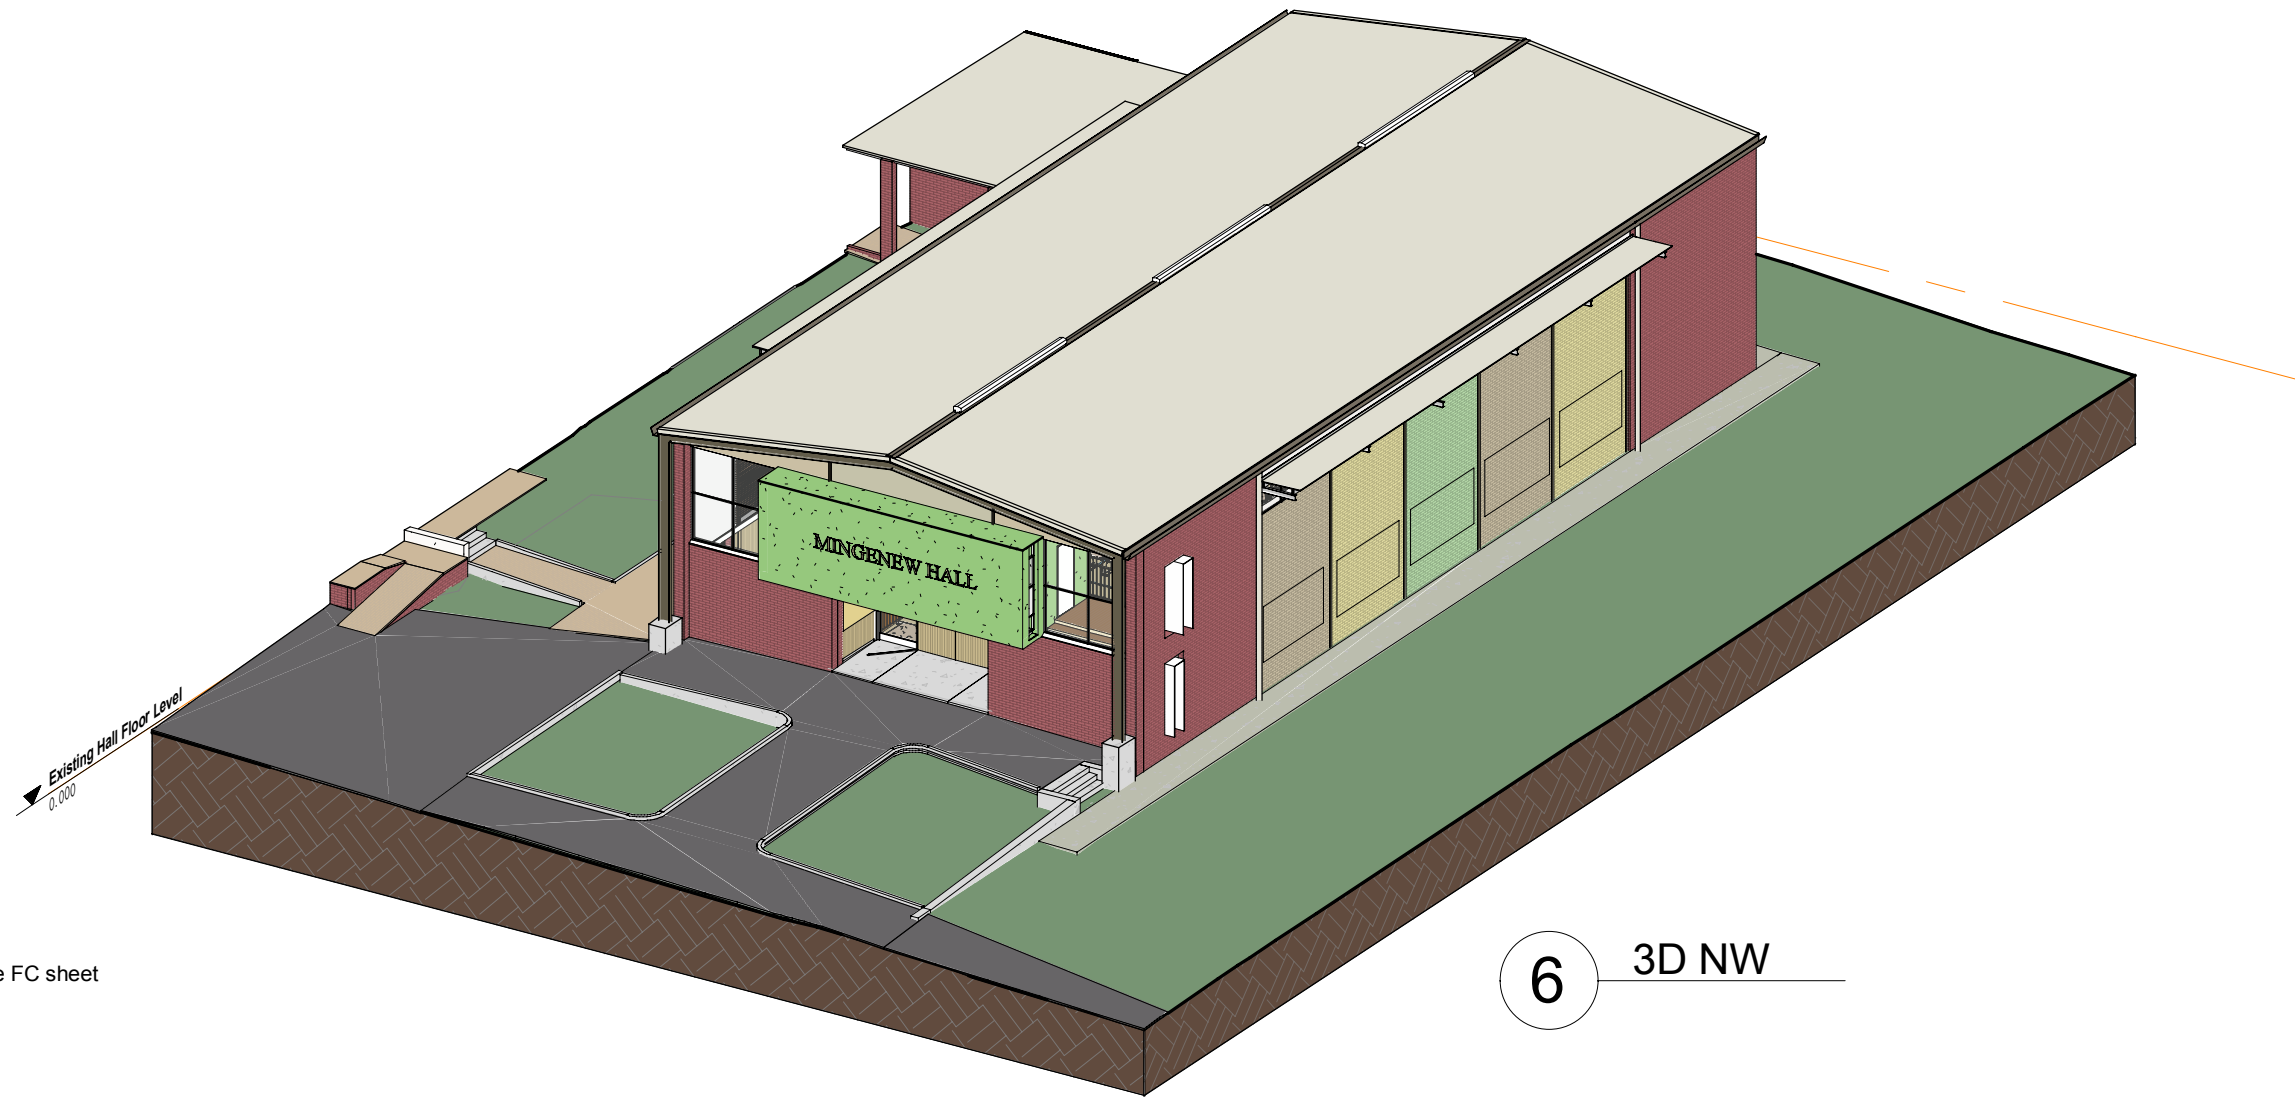
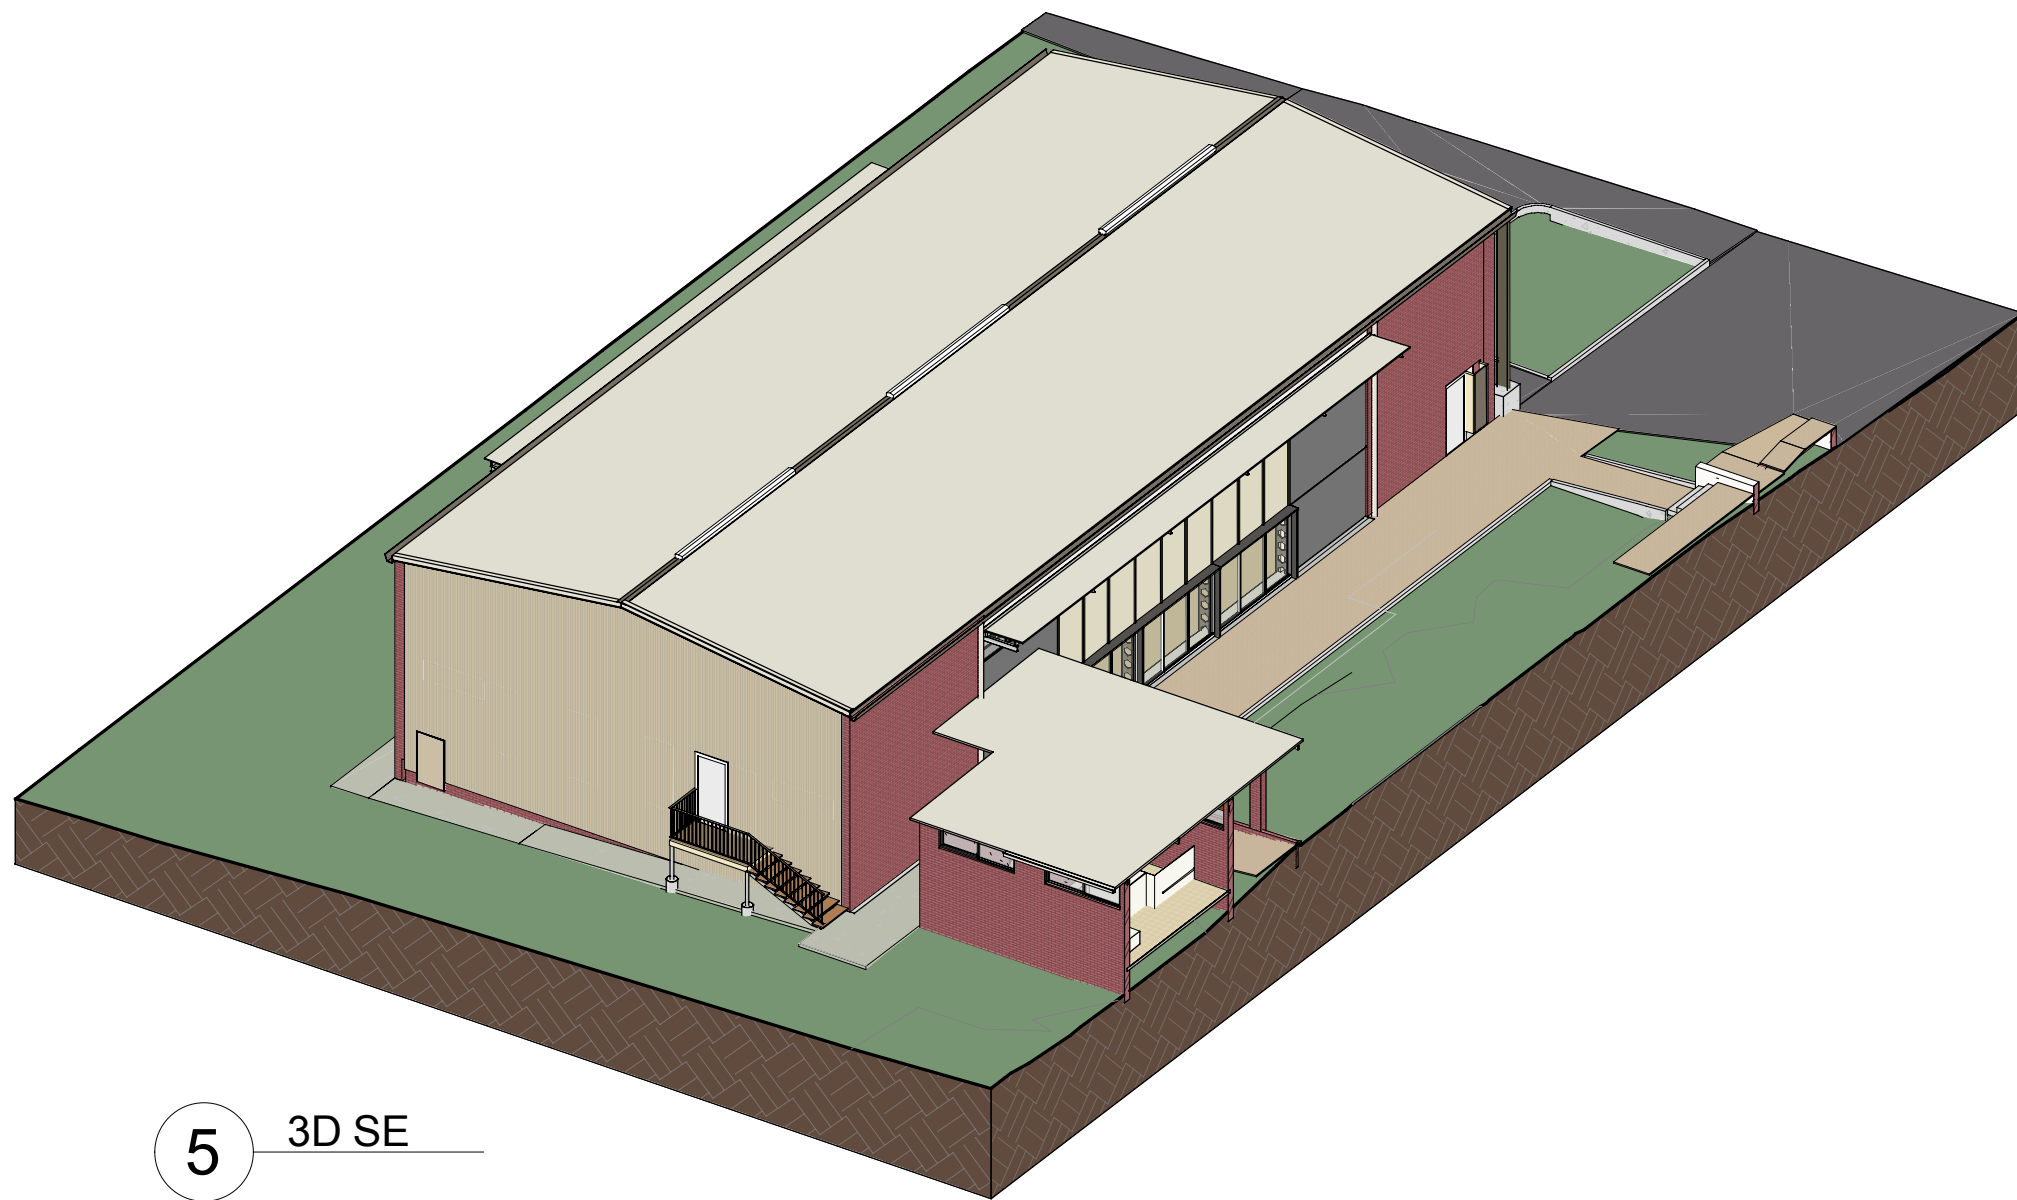
RW 1 Rebuild NW Wall

Demolish and rebuild masonry wall using existing bricks. New footing to engineer's detail. (Structure report suggests new 300mm wide footing down and onto the bedrock below. Drill and epoxy grout 4 equally spaced 800mm long N12 reinforcing bars, 400mm into the existing footing.

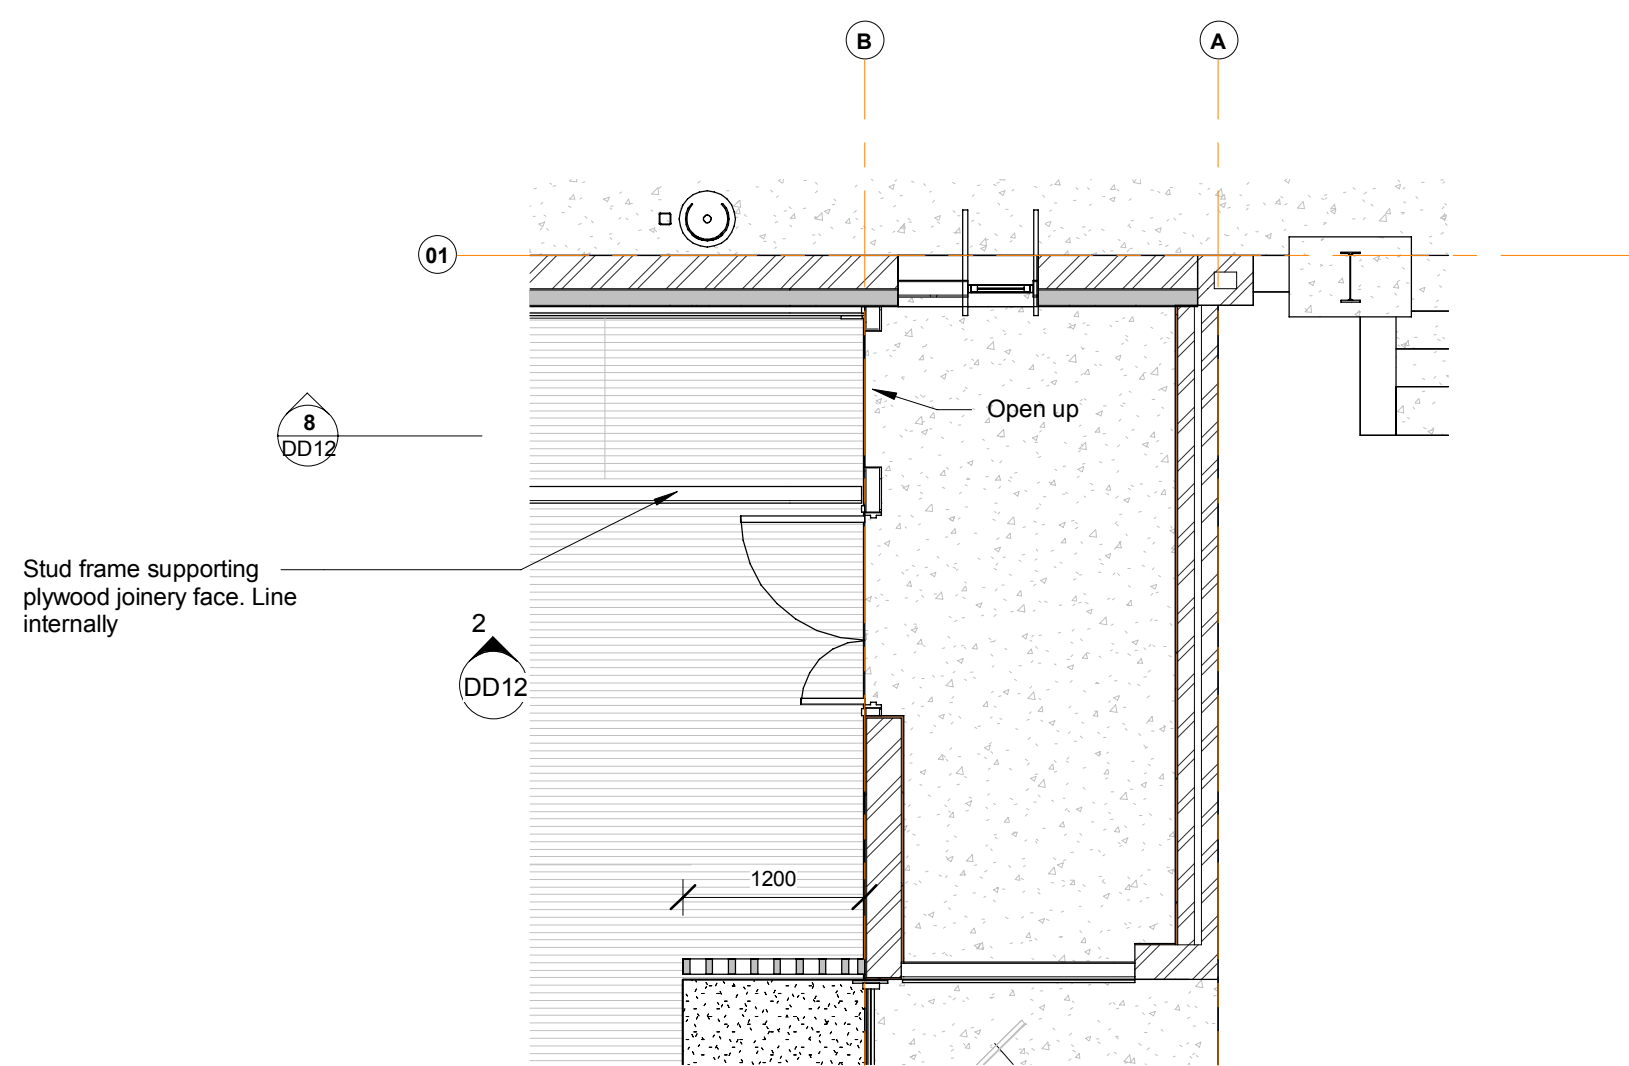
9 Mezzanine stairs (under)
1:50

Build new plywood stair and wall as a single joinery item to the mezzanine.
Provide BCA compliant galvanised steel circular balustrade and handrail to open side, and matching handrail to wall side.
Provide additional rail in front of eastern windows

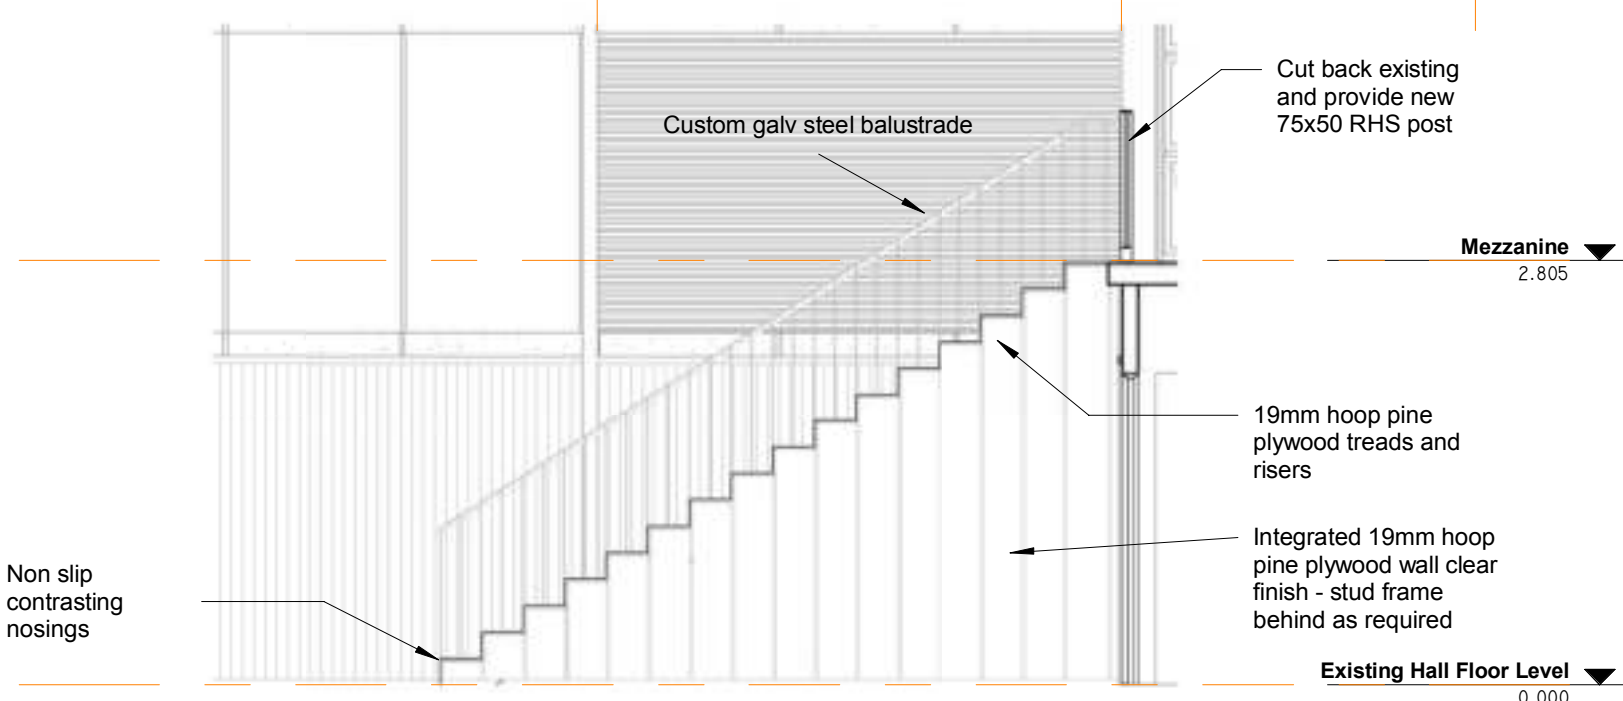
2 Stair elevation
1:50

SP4 Mezzanine Stair

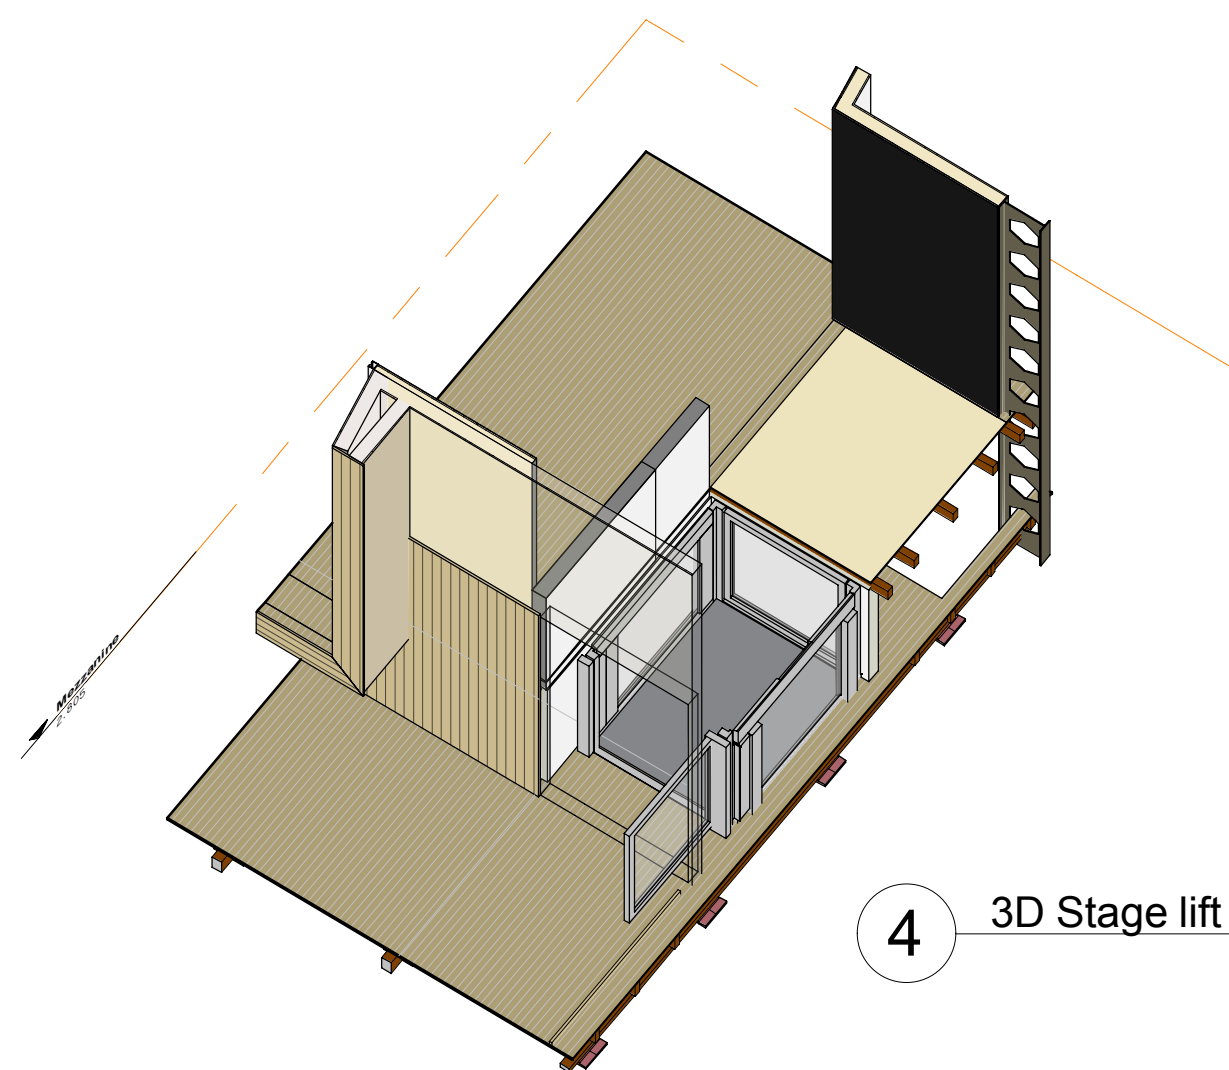
4 3D Stage lift

SP4 Platform Lift

Remove existing stair and cut new opening in stage wall. Extend upper landing and close off under stage. Install proprietary platform lift set down flush with hall floor level. Provide curtain to back of wall.

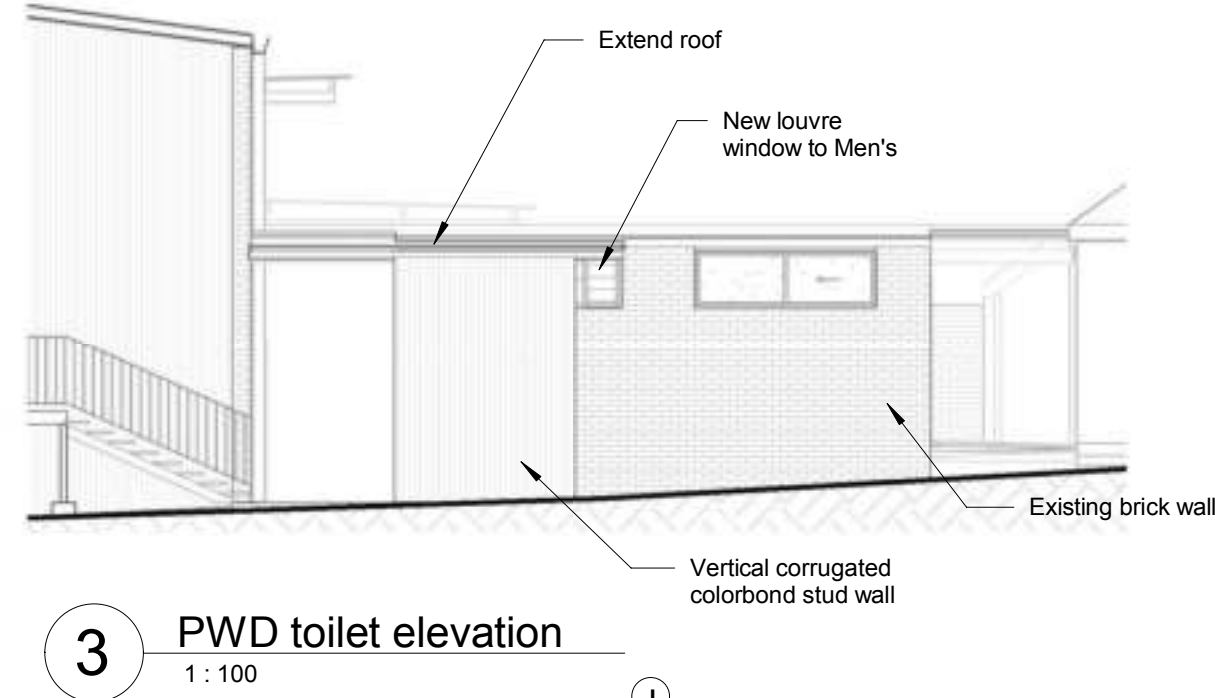
3 PWD toilet elevation
1:100

SP7 All Abilities Toilet

Build a complete accessible toilet enclosure compliant with AS1428.1. Connect to existing bathroom services.
Concrete slab on ground, corrugated clad stud walls, and roof to match existing.
Close off part Men's window at junction.
Solid core door, lock and indicator hardware, sliding glass window.

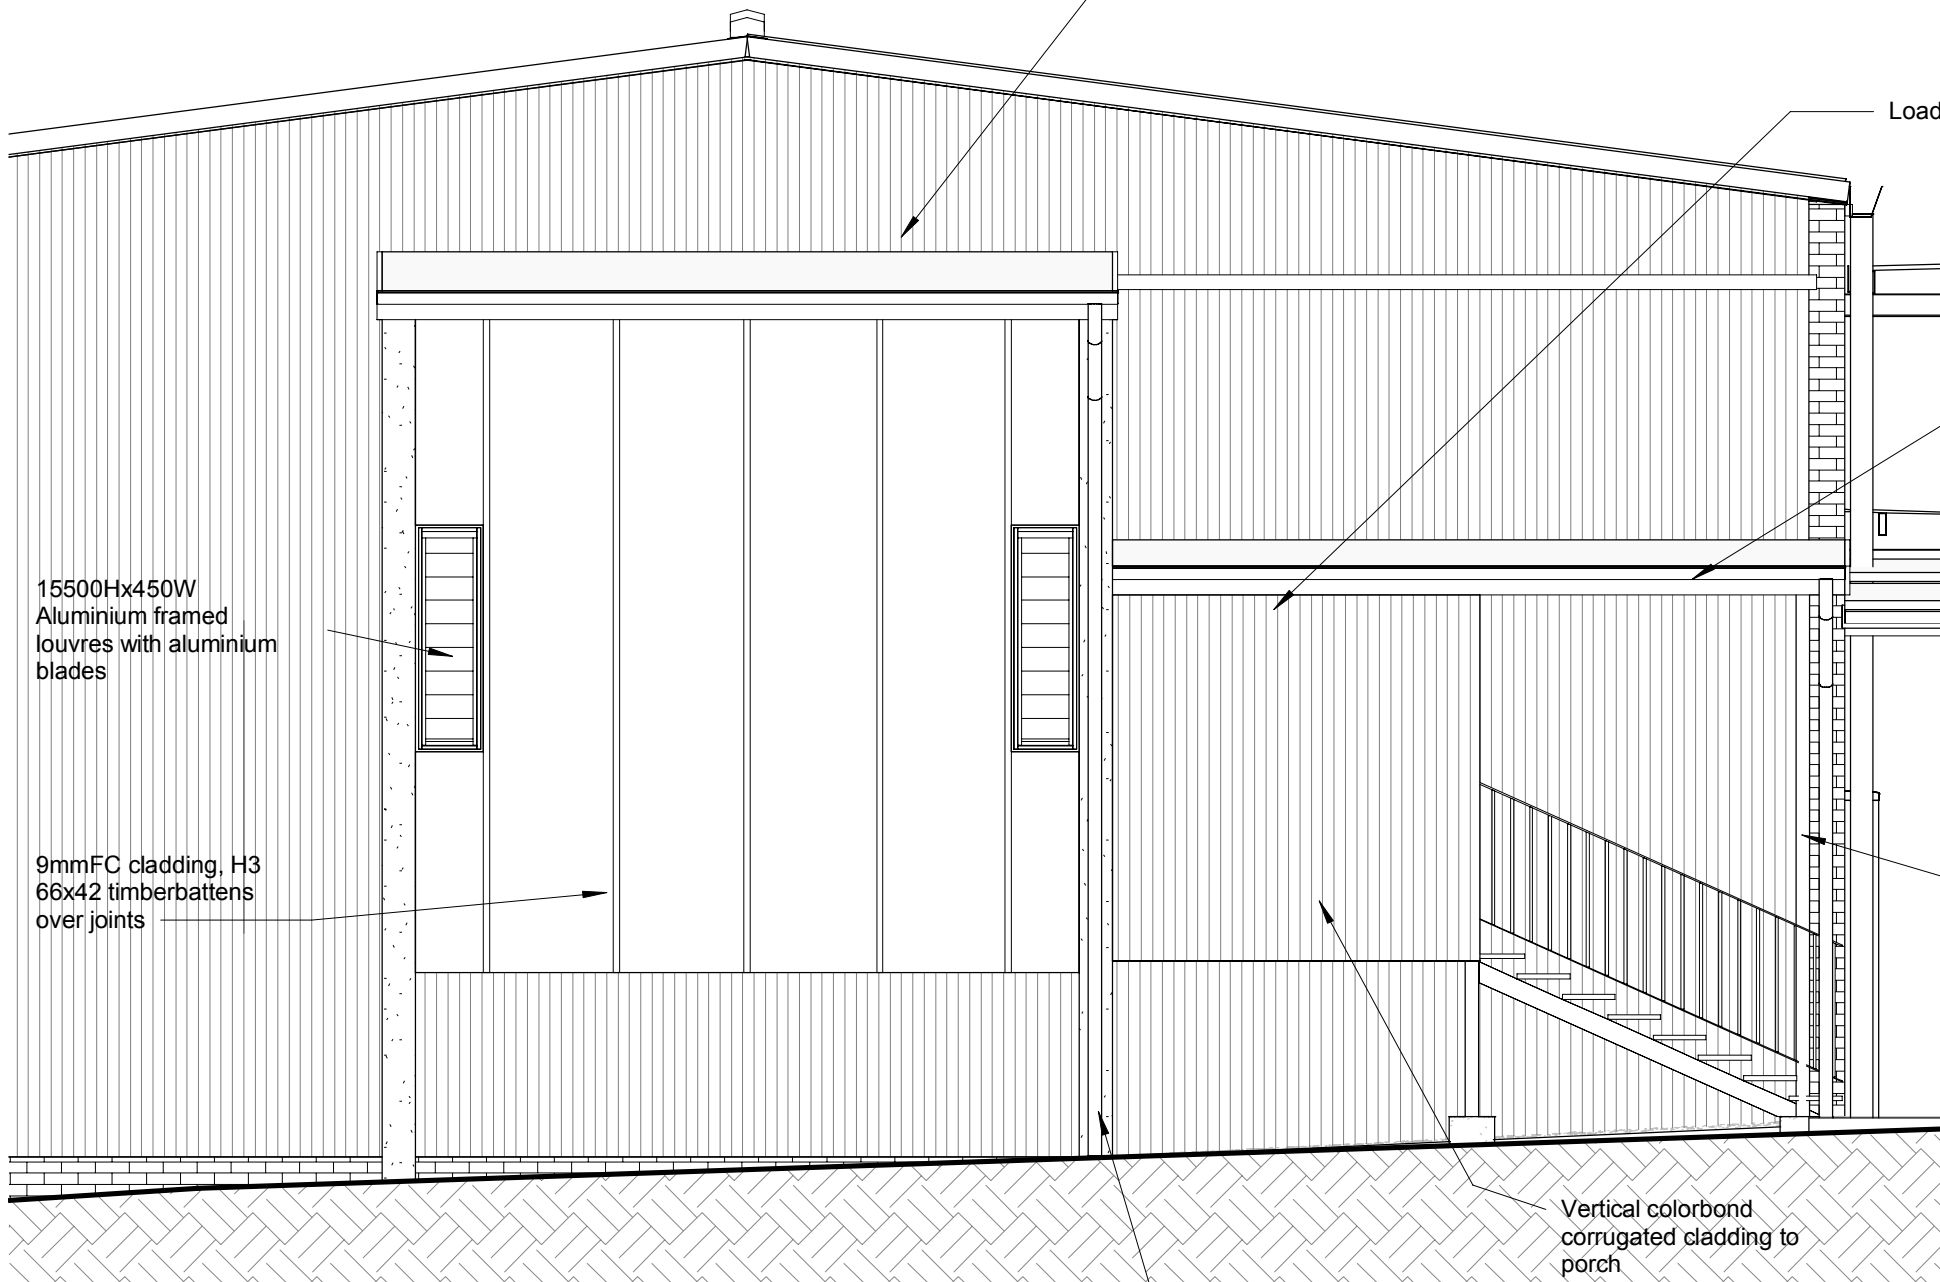
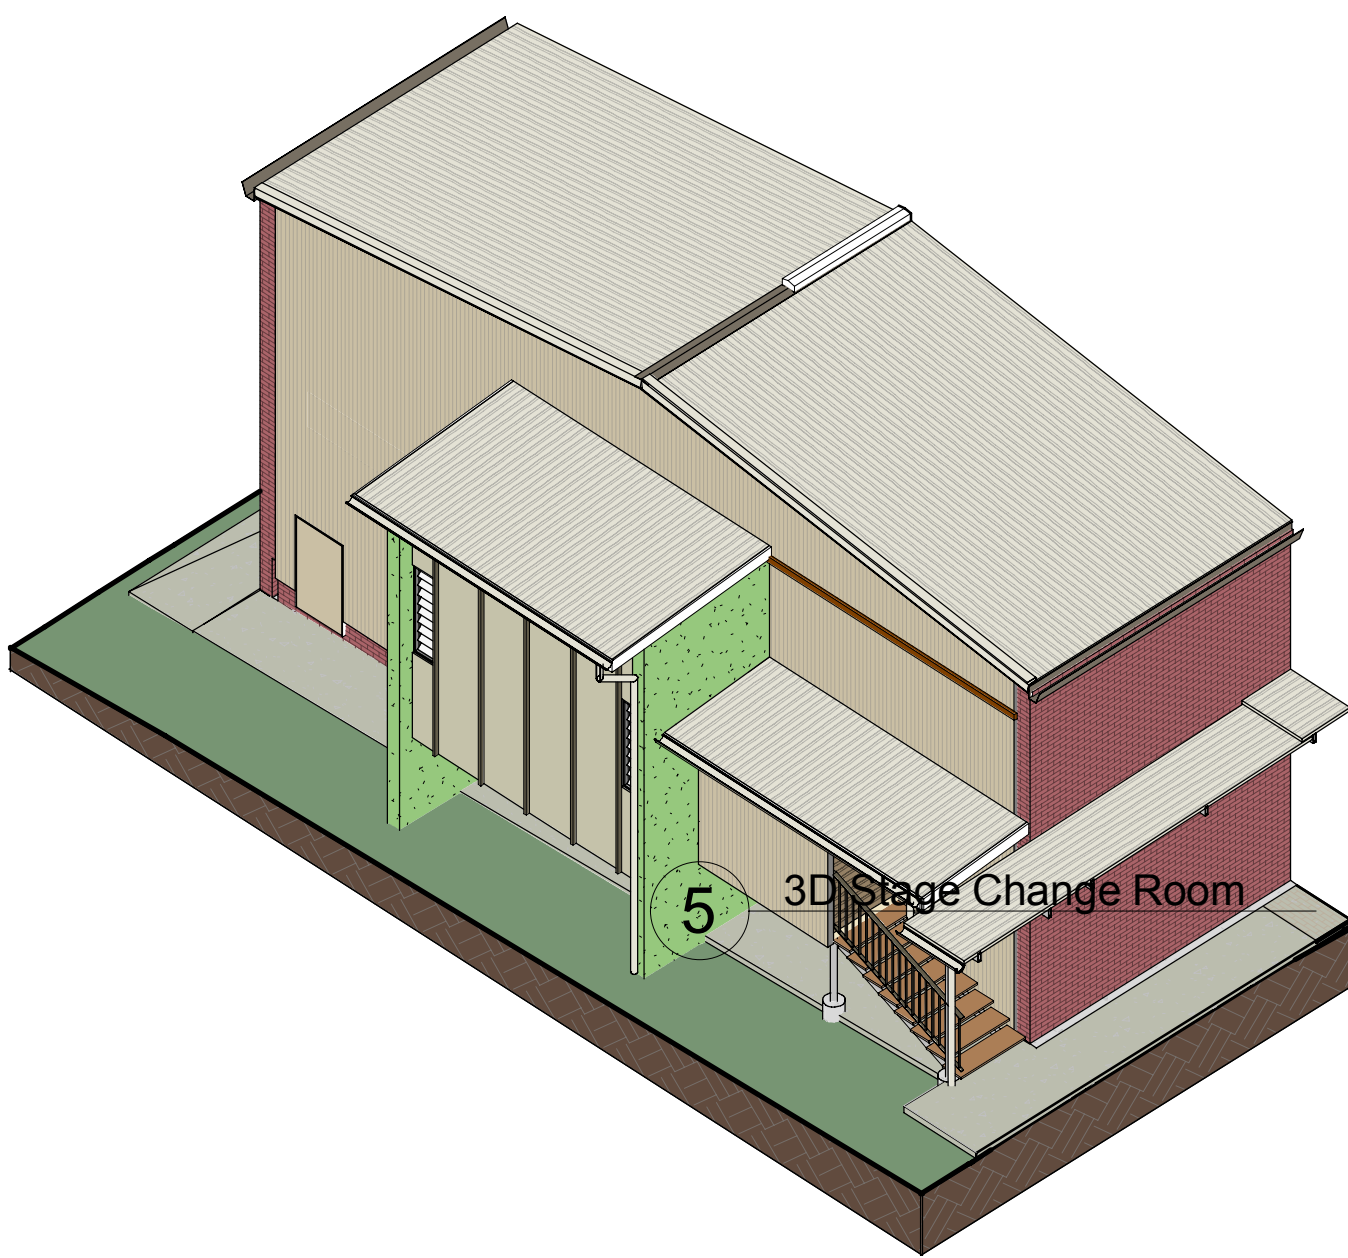
5 3D Stage Change Room

SP 8 Stage Change Room

200 series reinforced concrete masonry wall, acrylic render finish. Build on RC strip footings

Vertical colorbond, corrugated cladding to porch

Downpipes to ground swales
